Your Inspection Report

179 Glendale
Toronto, ON

Thursday, May 14, 2015

Report No. 1469, v.3

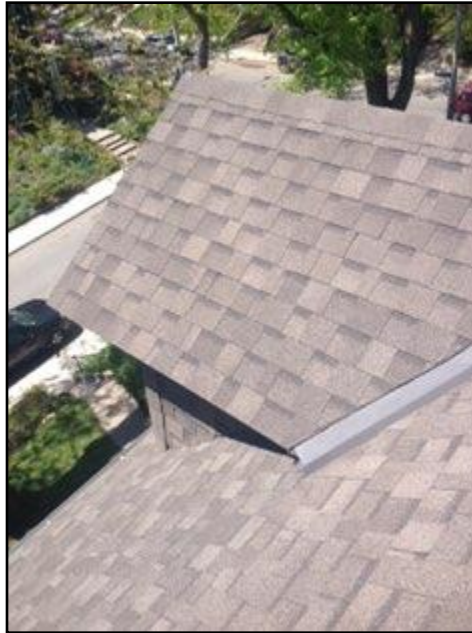
Sloped areas aprox. 5 years old.

1. *Asphalt shingles*

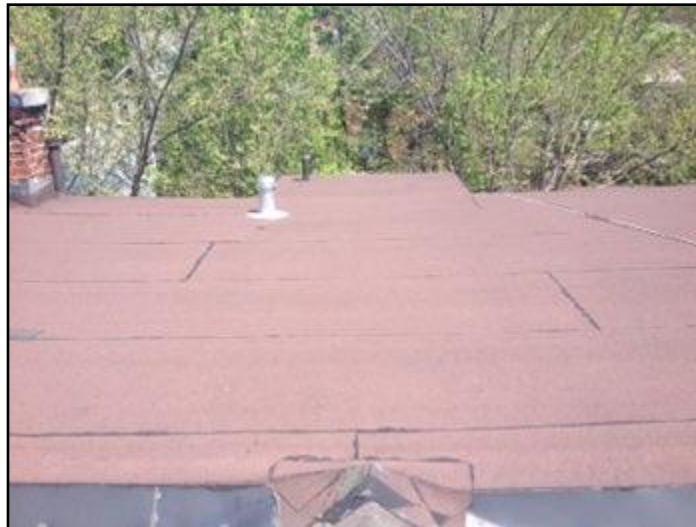
Flat roof aprox. 8-10 years old.

2. *Modified bitumen*

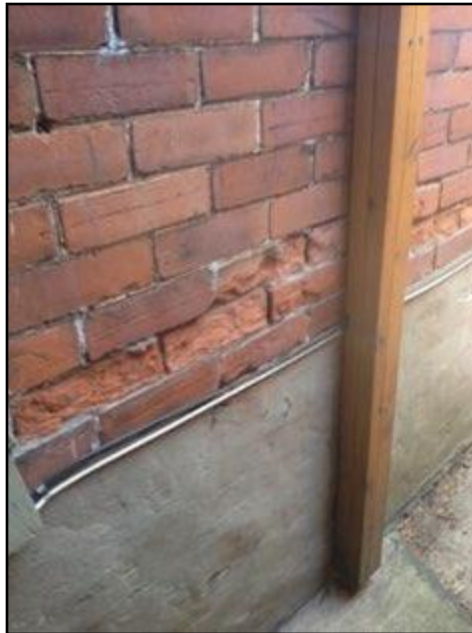
Minor parging needed, not urgent.

3. Parging damaged or missing

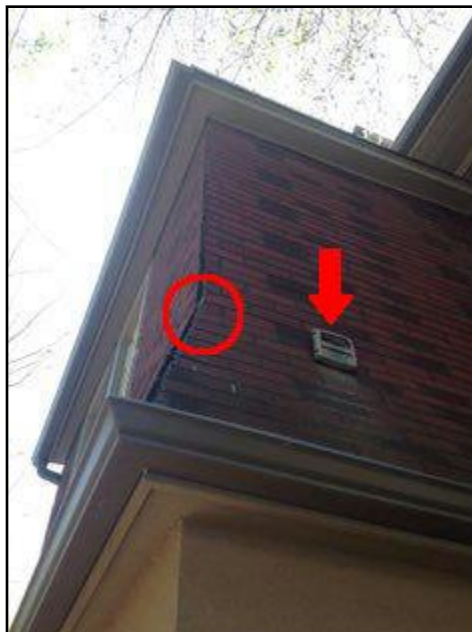
5. Condition: • [Damaged](#)

4. Damaged

Seal joint and resecure vent to prevent leakage.

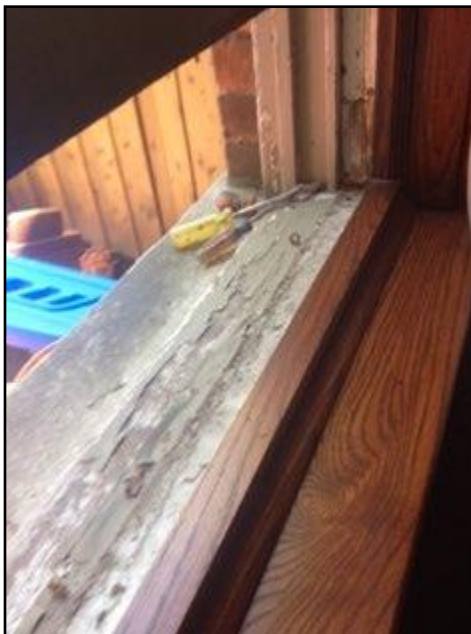
Typical paint and caulking maintenance needed at wood trim if not replacing windows.

5. *Paint or stain needed*

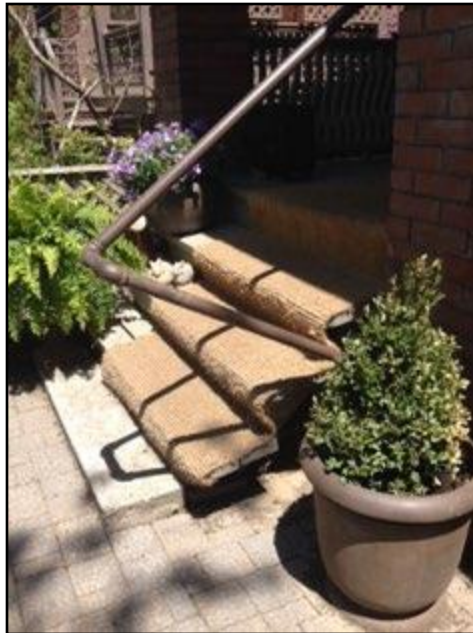
Porch steps awkward.

6. Steps slope

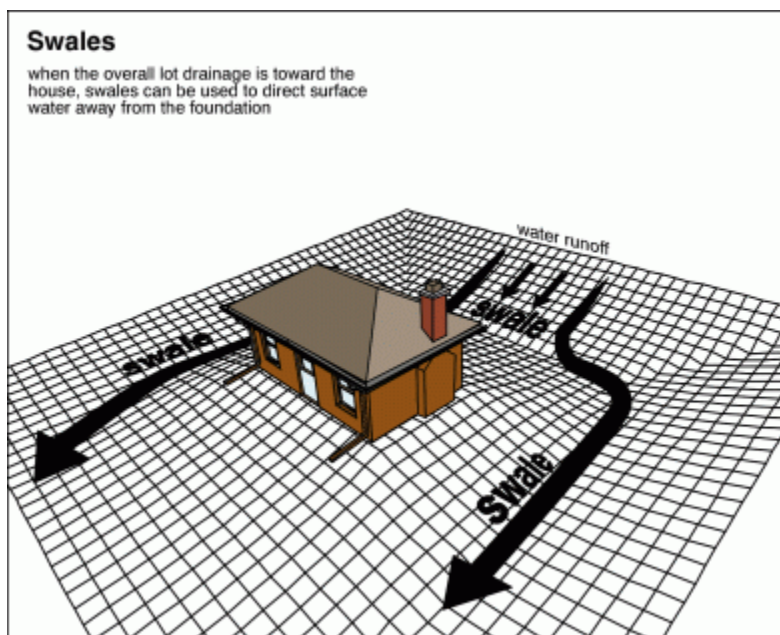
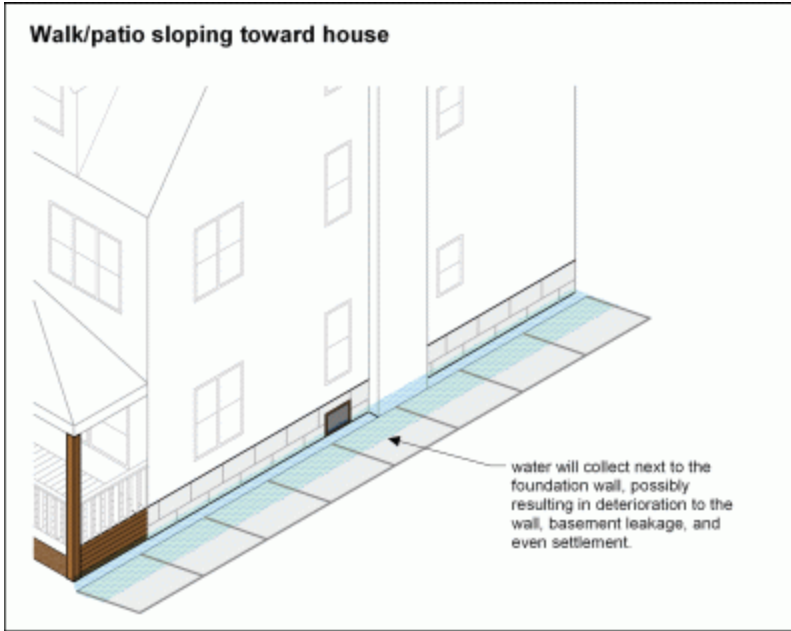
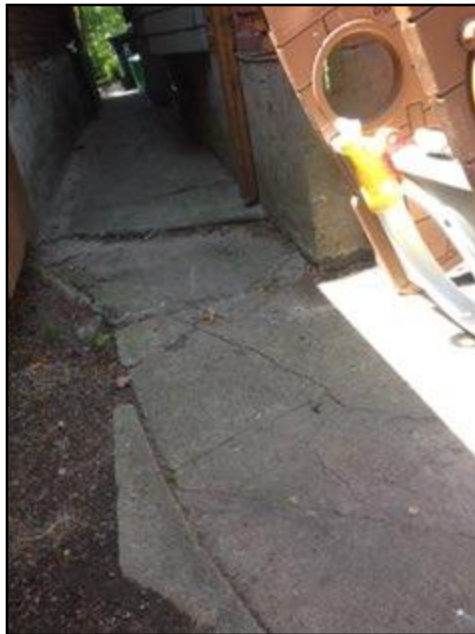
Walkway at Southeast corner funnels water towards foundation. Some seepage evident in this area of basement. Exterior waterproofing desirable, replace and reslope walk after installation.

7. Improper slope or drainage

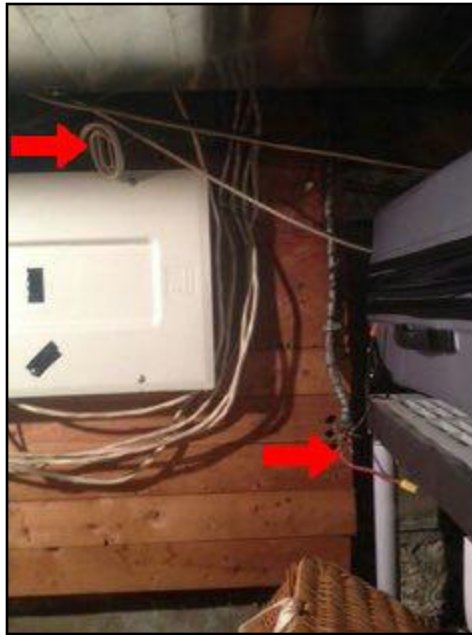
8. Abandoned wires

Remove abandoned wires from panel and junction box.

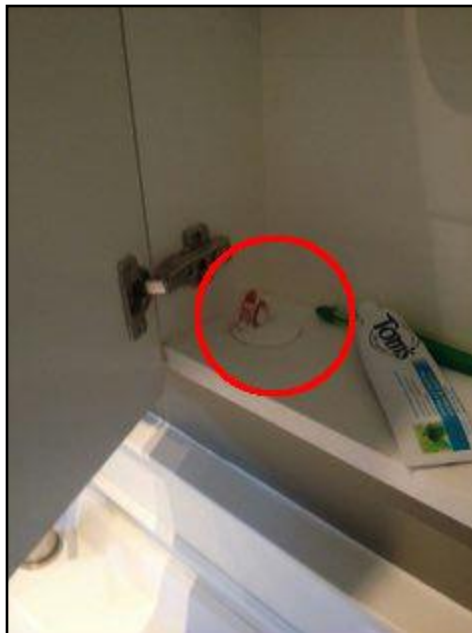
9. Roughed in wire

11. **Condition:** • Add receptacle at washroom wall. if not using exposed wire, terminate properly in junction box.

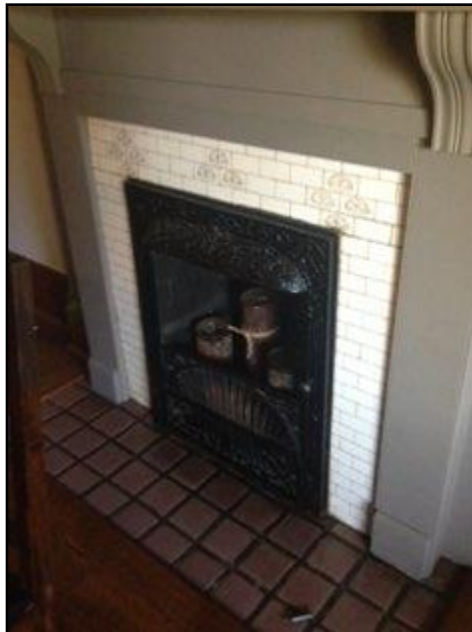
10. Coal-burning fireplace - not in service

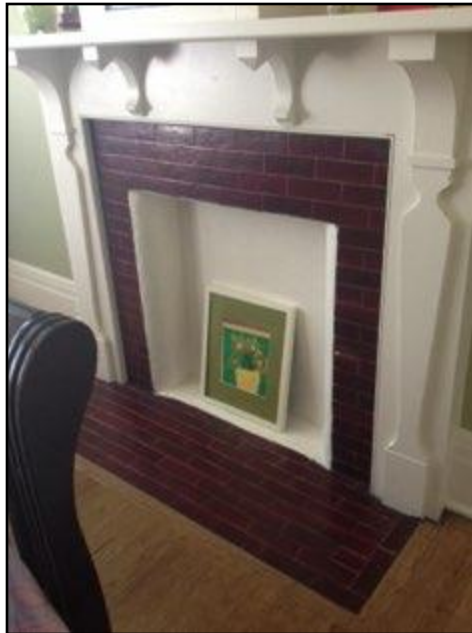
11. Decorative only

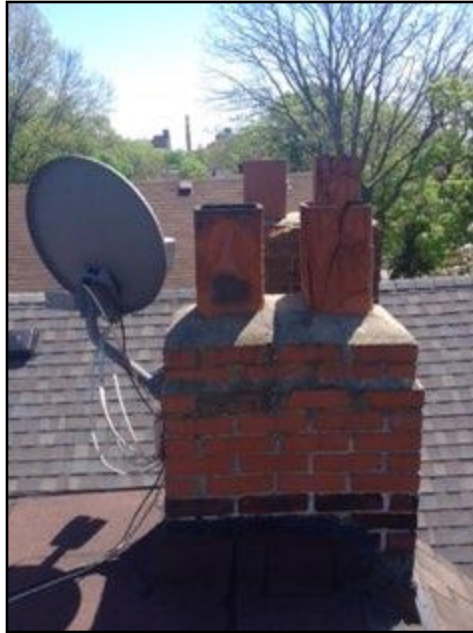
13. Condition: • Living room fireplace built for coal. Separate flue available if conversion to gas or wood is desired. Do not use in present condition. Add pest screens to chimney top.

12. Available flues

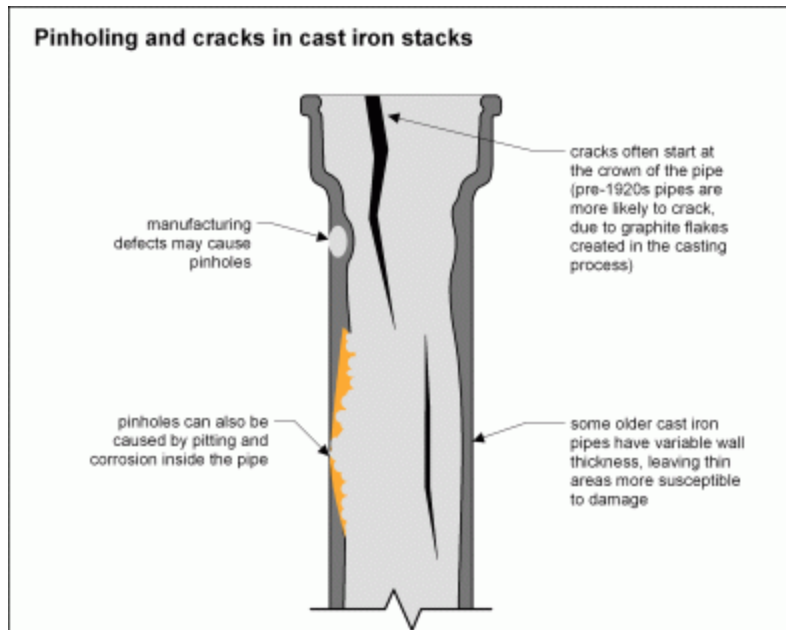
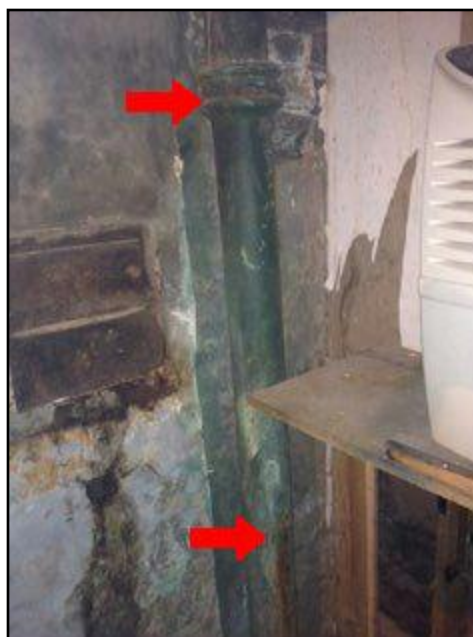
Typical rust present on cast iron waste piping, replace when renovating basement.

13. Rust

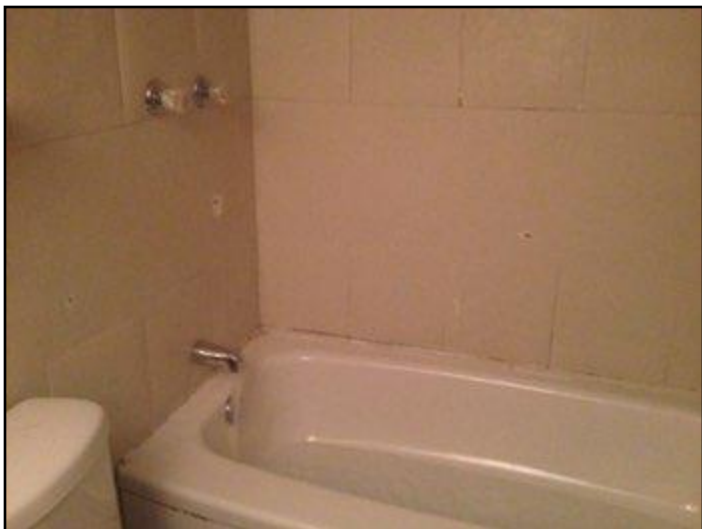
Tub surround due for replacement at basement washroom. See Waste piping before renovating.

14. Leak

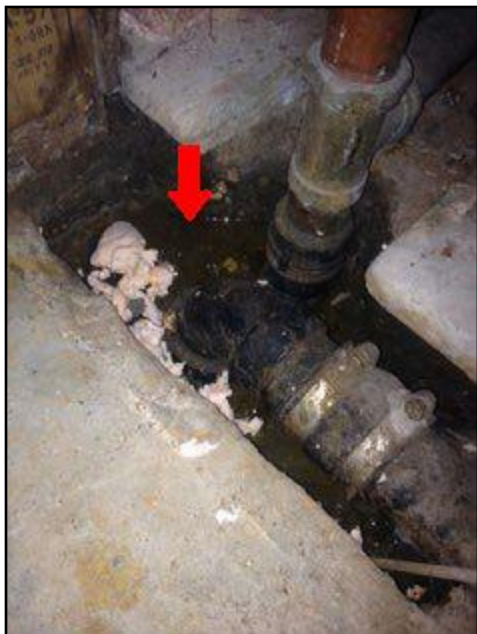
15. Water on floor

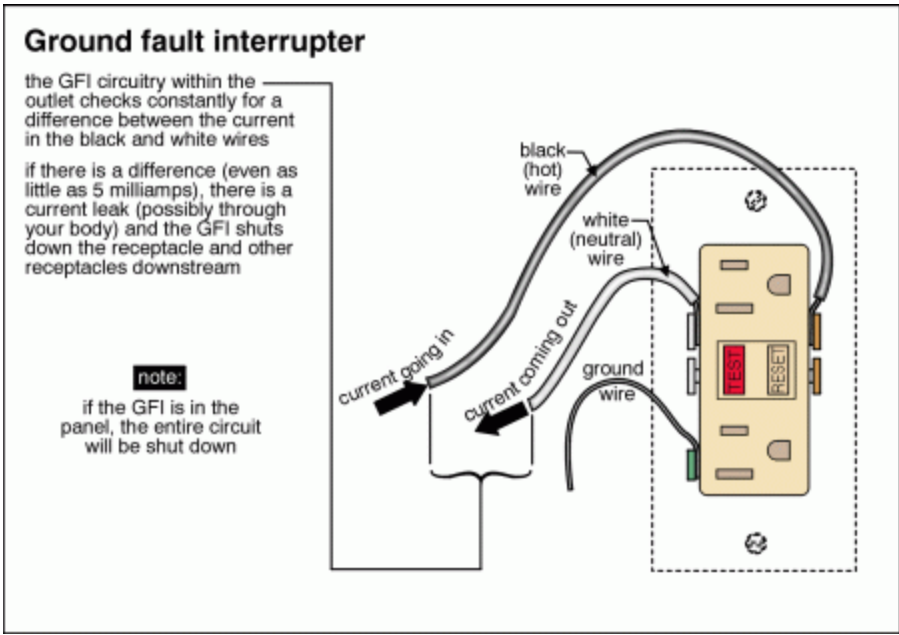
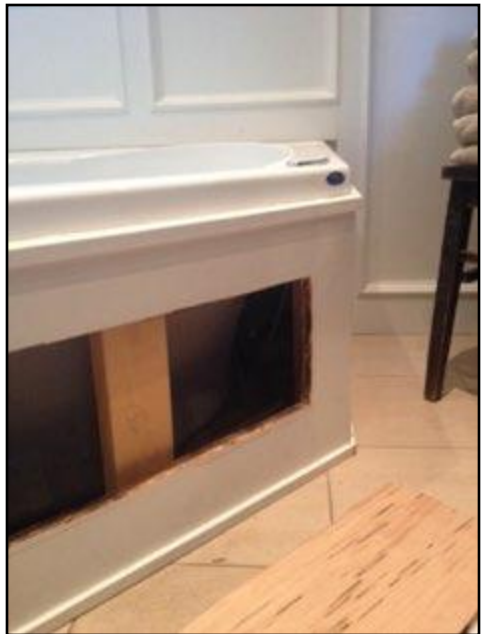
16. No GFCI

GFCI can be added within tub enclosure.

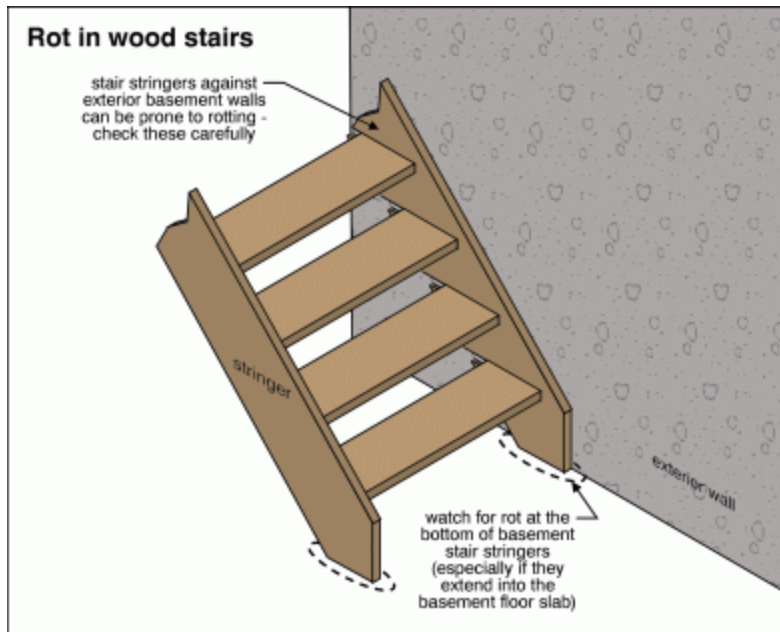
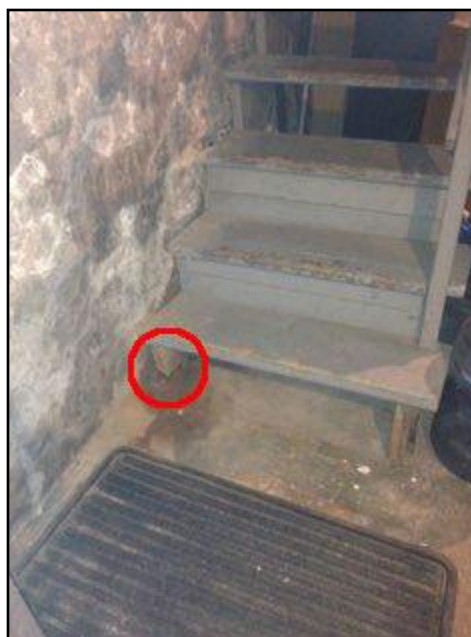
Sag in stairs due to rot. Isolating base of stringer from void in floor will correct issue in short term. Basement dampproofing is needed if renovating basement.

17. Rot at bottom

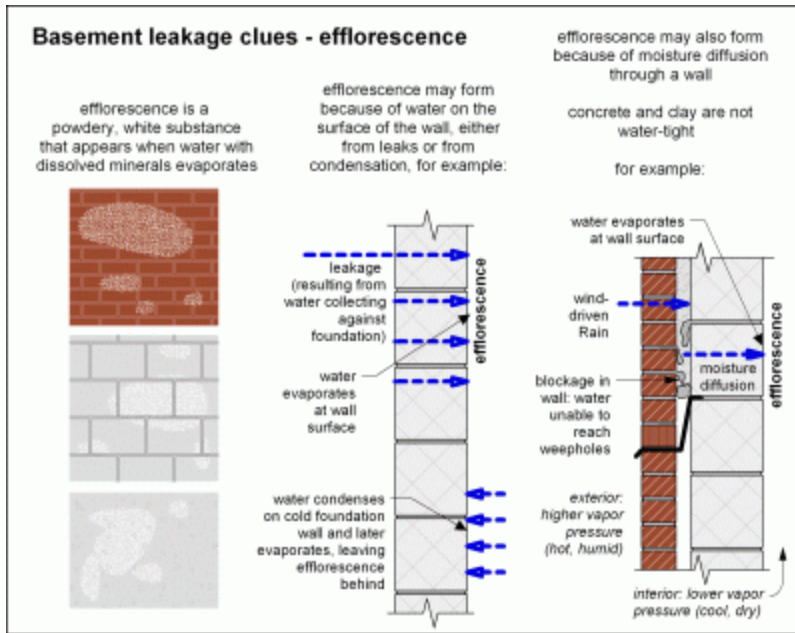
Efflorescence at main basement is typical, parge walls and introduce interior membrane if finishing basement.

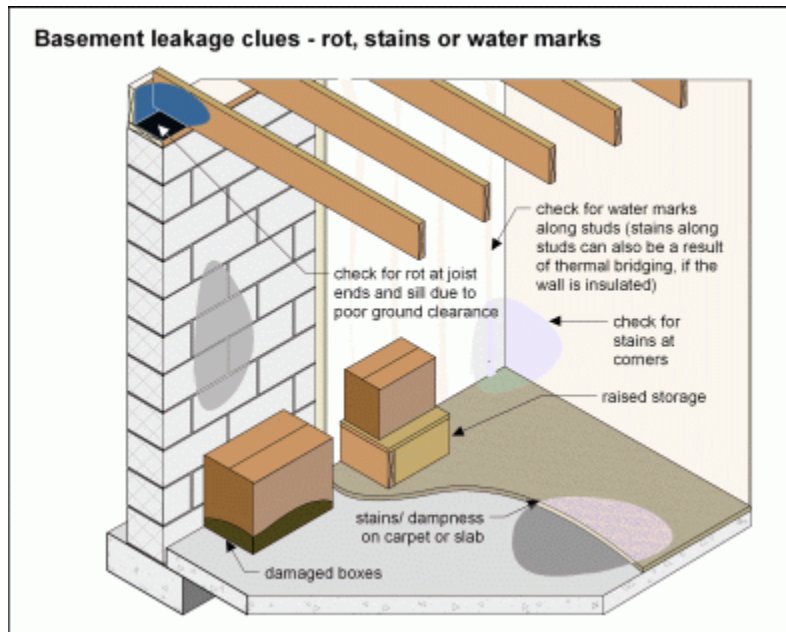
Some areas of basement require waterproofing due to water entry. Water at east basement is due to water penetrating foundation, water at mid north wall requires further evaluation.

18. Water marks
