57 Stafford Avenue, Toronto, Ontario

SUMMARY INSPECTION REPORT

PROPERTY: 57 Stafford Avenue, Toronto, Ontario

INSPECTION REPORT

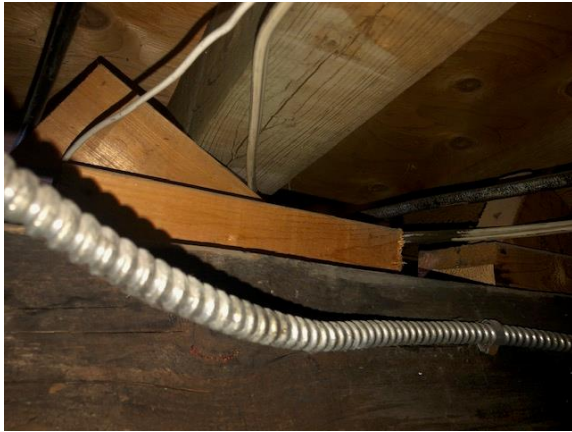
G: the kitchen floor has been rebuilt on top of the existing flooring system using 4x4 wood beams to provide a level surface. Framing detail used is unconventional, but appears to be effective as the floors felt solid when walked upon. It is recommended however that a framing carpenter examined this area of the flooring system to ensure there is no chance of movement in the future. Monitor.

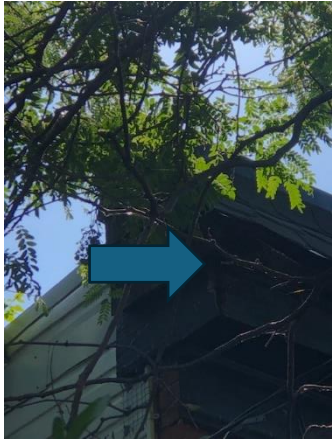
G: there is a hole in the roof overhang at the northwest corner due to wildlife activity. Repairs are recommended with wire mesh (as has already been done above). There is an exit trap in this location due to past wildlife activity. Once this area has been sealed properly, the trap may be removed.

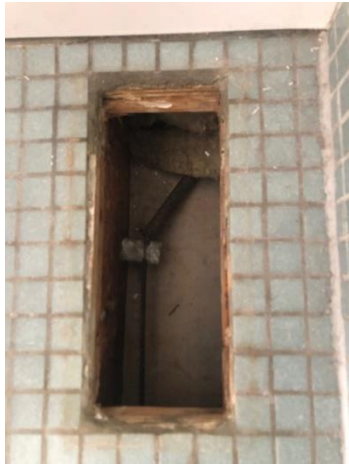
G: there is a circuit visible in the 2nd floor bathroom heat register that appears to be energized and is original knob-and-tube wire. It could not be traced. You may want to have this further investigated and the circuit eliminated if it is still in use.
