# Your Inspection Report

60 Spencer Avenue  
Toronto, ON M6K 2J6

RE: Report No. 4065  
60 Spencer Avenue  
Toronto, ON  
M6K 2J6

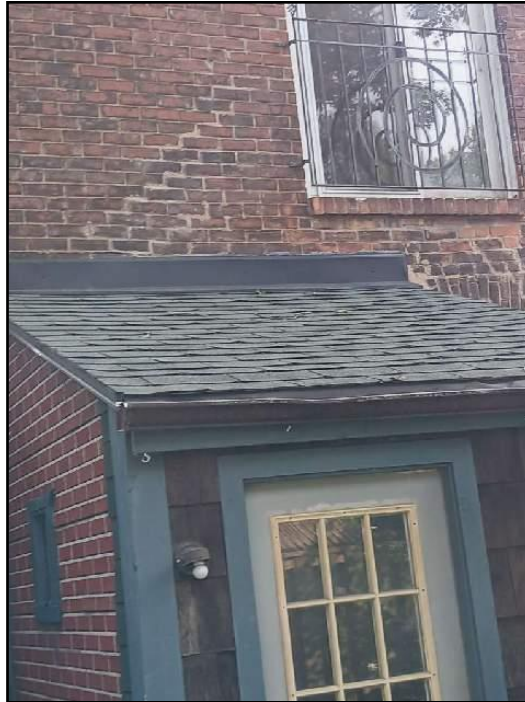
1.

- [Asphalt shingles](#)

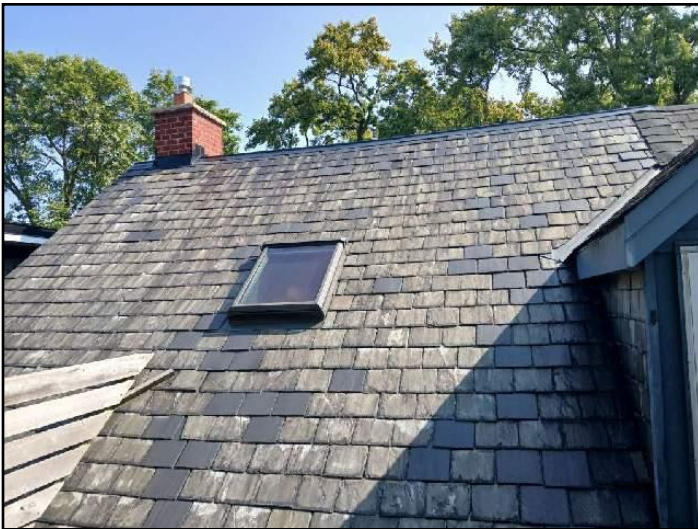
2.

- [Slate shingles](#)

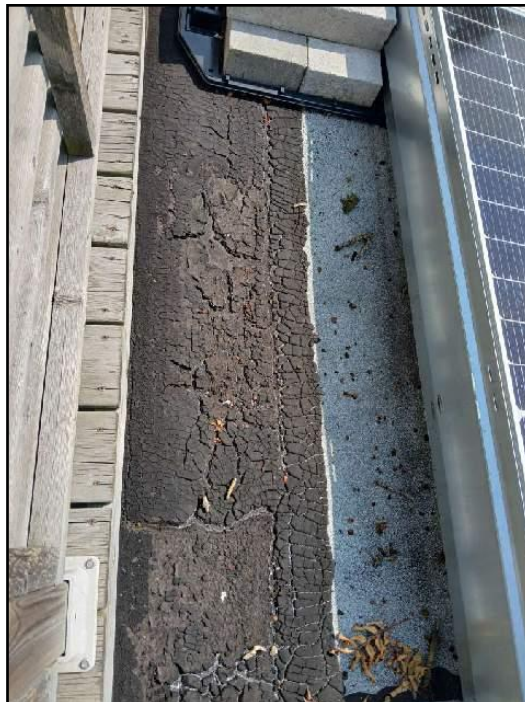
4.

**1. Condition:** • Aging

Flat roof has some alligating, inspect annually and budget for replacement.

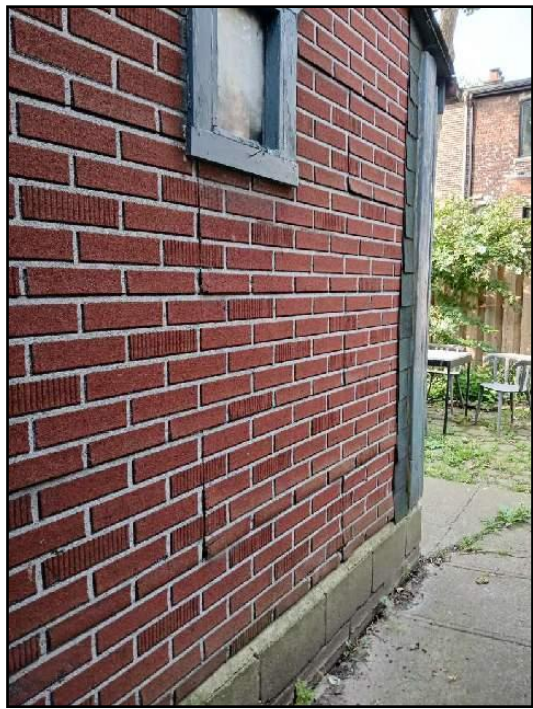
5.

**WALLS \ Asphalt shingles**  
**2. Condition:** • [Aging](#)  
Insulbrick will require eventual residing.  
**Implication(s):** Chance of water damage to structure, finishes and contents  
**Location:** Northwest Exterior Wall  
**Task:** Replace  
**Time:** Unpredictable  
**Cost:** Minor

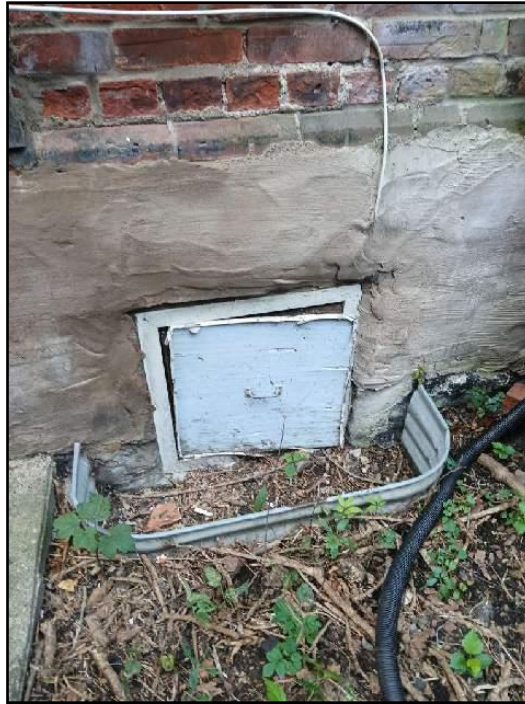
6.

**3. Condition:** • Abandoned windows poorly sealed.

Two poorly sealed windows at basement, recommend restoration.

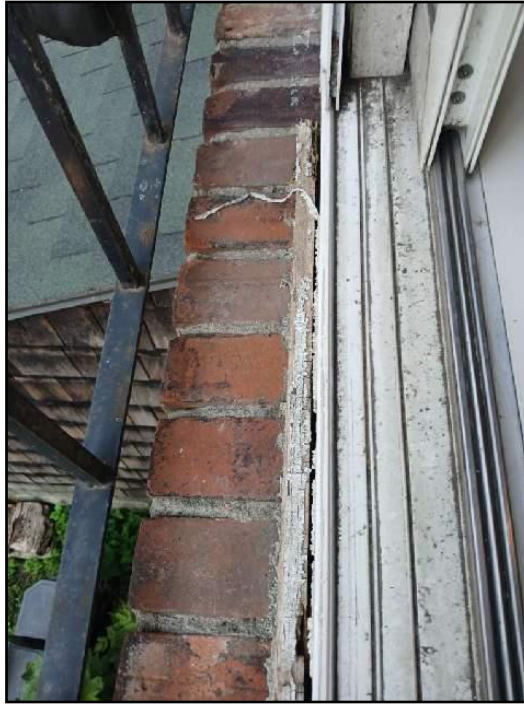
7.

**4. Condition:** • Threshold leaks.

Seal sill at sliding door.

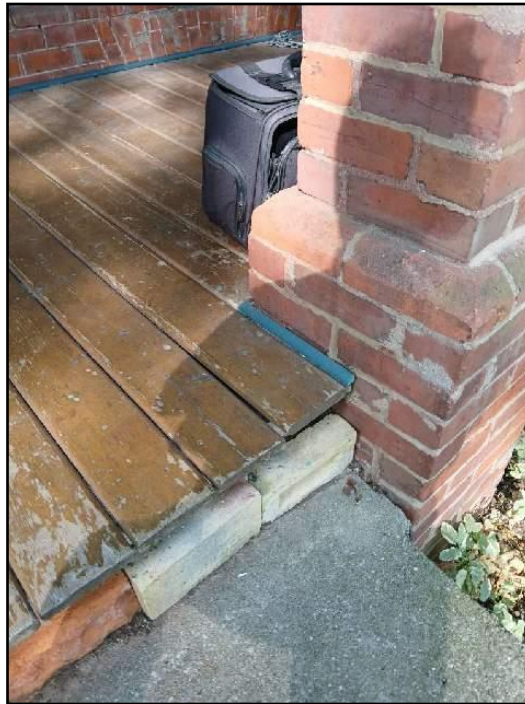
8.

**5. Condition:** • Loose deck board

**Implication(s):** Trip or fall hazard

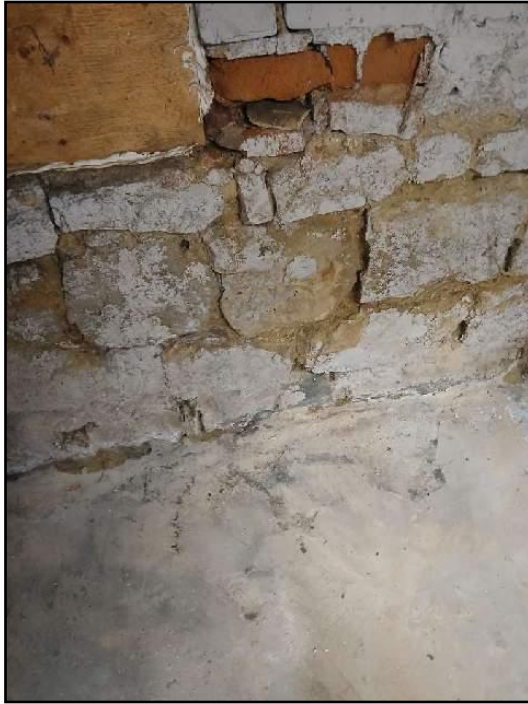
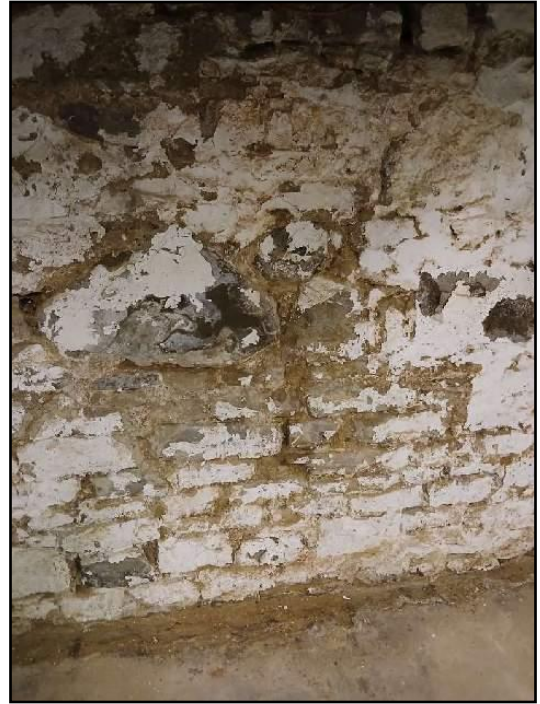
**6. Condition:** • [Mortar deteriorated or missing](#)

Some parging repairs needed at cracks and joints in basement.

**Implication(s):** Weakened structure | Chance of structural movement

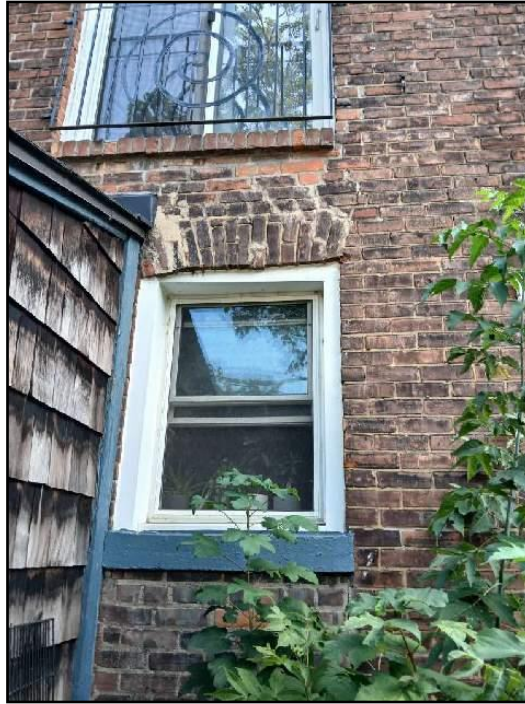
11.

### 7. Condition: • [Dropped, rotating or leaning](#)

Replace arch with steel lintel.

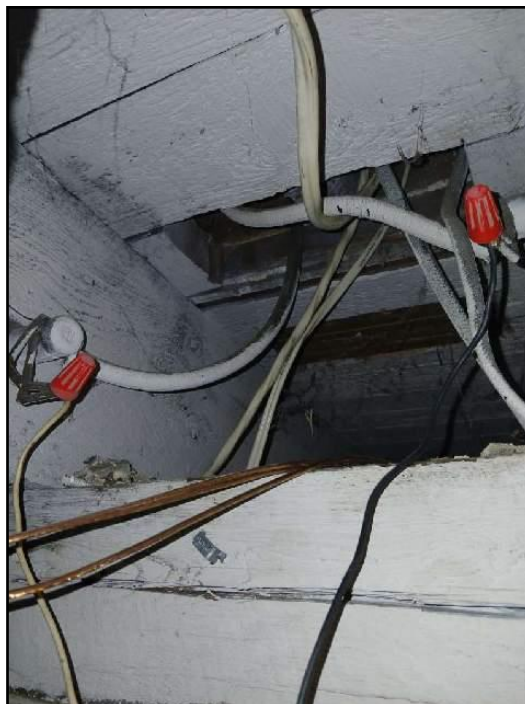
12.

**8. Condition:** • [Outdated](#)

Two circuits of knob and tube remain in use.

**Implication(s):** Nuisance | Potential problem when obtaining home insurance

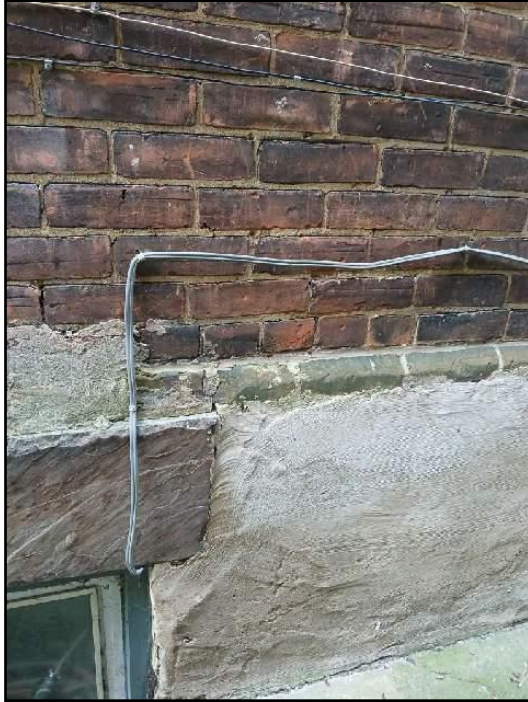
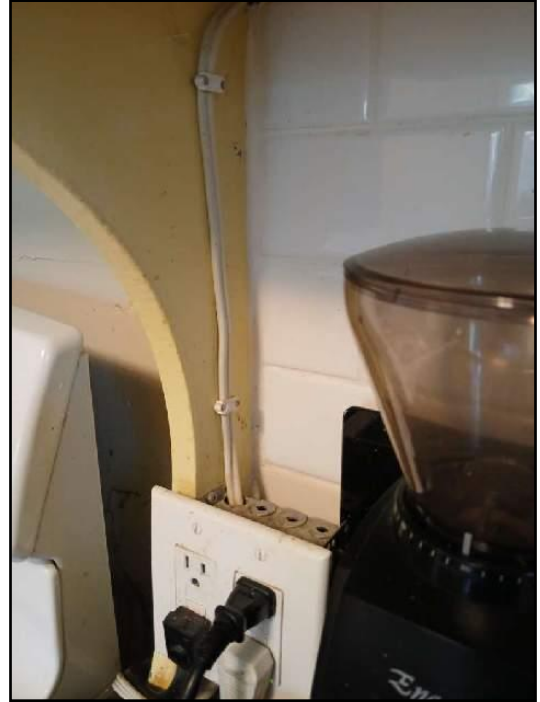
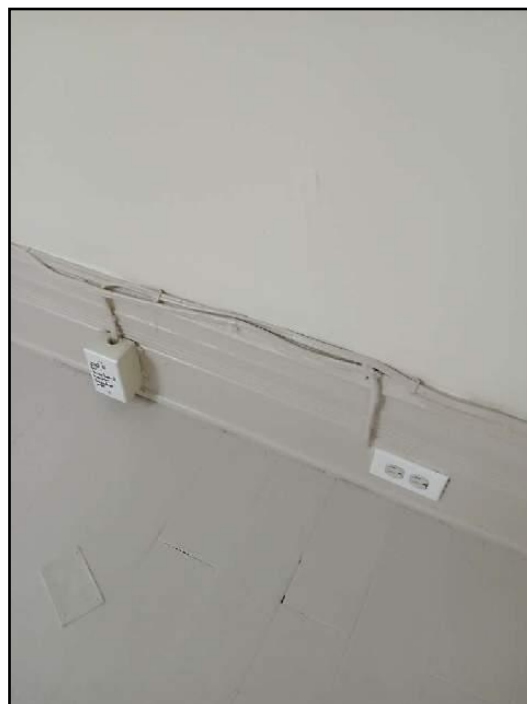
9. **Condition:** • Cover exposed wiring with conduit.

Cover wiring or recess within walls.

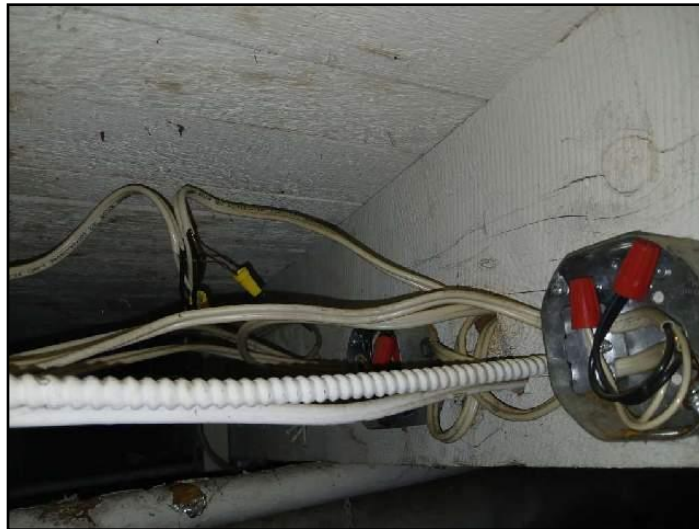
16.

### 10. Condition: • [Missing](#)

Add junction boxes at open splices and covers where missing.

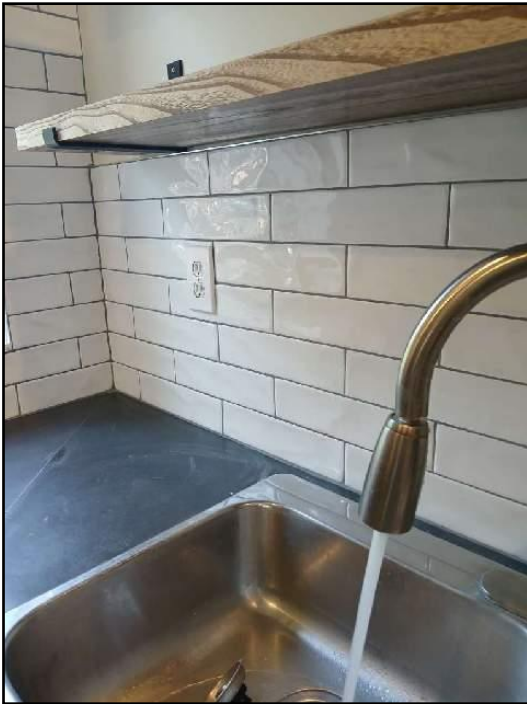
17.

### 11. Condition: • [GFCI/GFI needed \(Ground Fault Circuit Interrupter\)](#)

Recommend gfci receptacles at all wet locations.

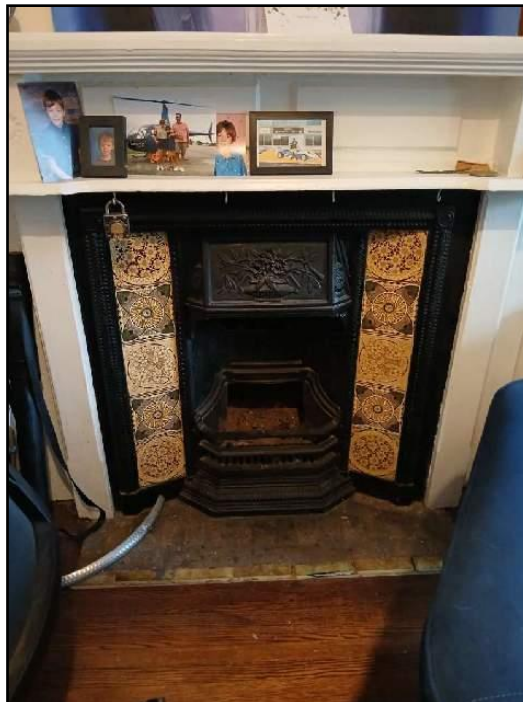
18.

• Coal-burning fireplace - not in service

Flue is sealed, do not use.

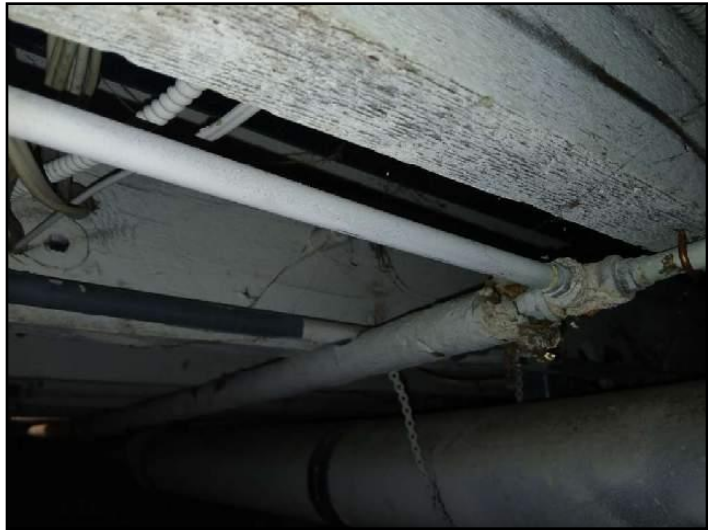
20.

**15. Condition:** • [Galvanized steel](#)

Small amount of galvanized steel piping in use.

**Implication(s):** Reduced water pressure and volume

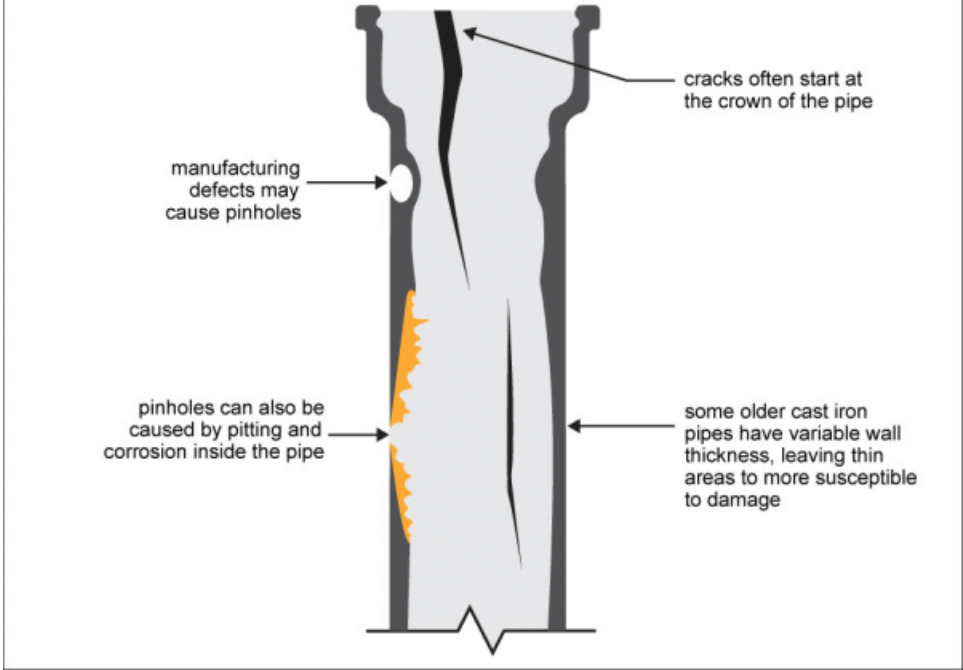
16. Condition: • [Rust](#)

**Pinholing and cracks in cast iron stacks**

Replace original waste piping as access permits.

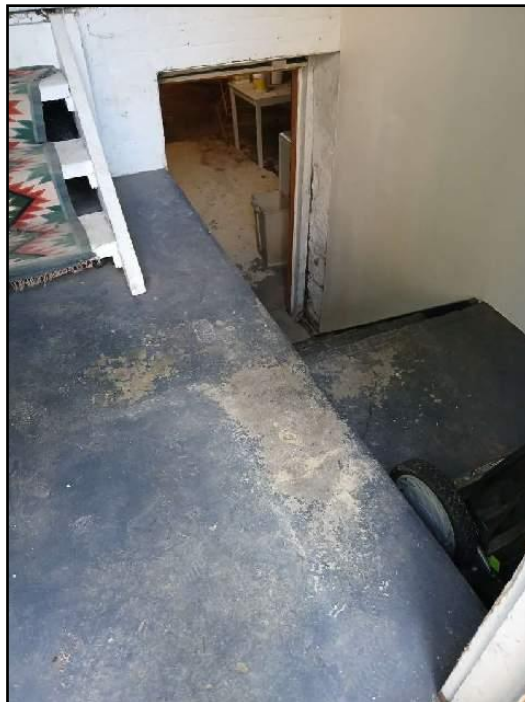
21.

19. Condition: • [Missing](#)

Implication(s): Fall hazard

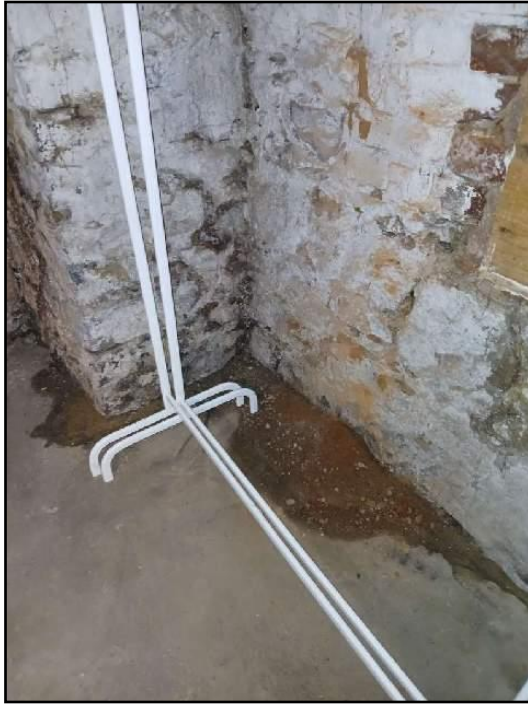
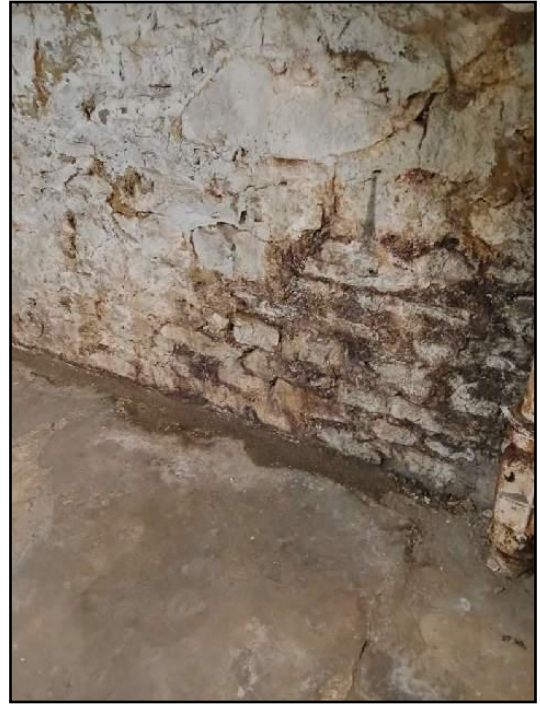
### **20. Condition:** • [Dampness on floor or walls](#)

Typical dampness and cracks for this era and type of construction. Recommend interior foundation membrane system if renovating basement.
