Your Inspection Report

4242 Fieldgate Drive
Mississauga, ON L4W 2E2

Wednesday, October 23, 2024

RE: Report No. 4113
4242 Fieldgate Drive
Mississauga, ON
L4W 2E2

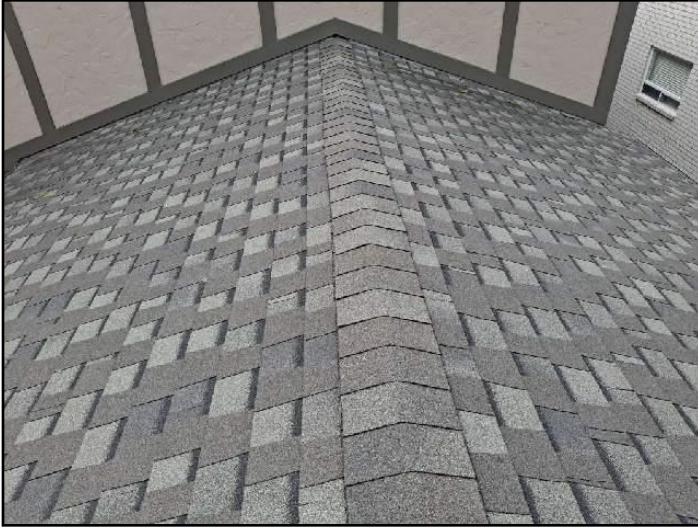
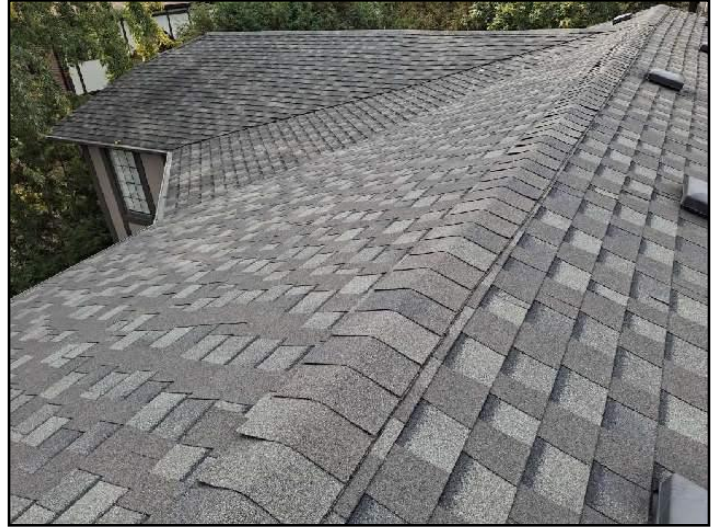
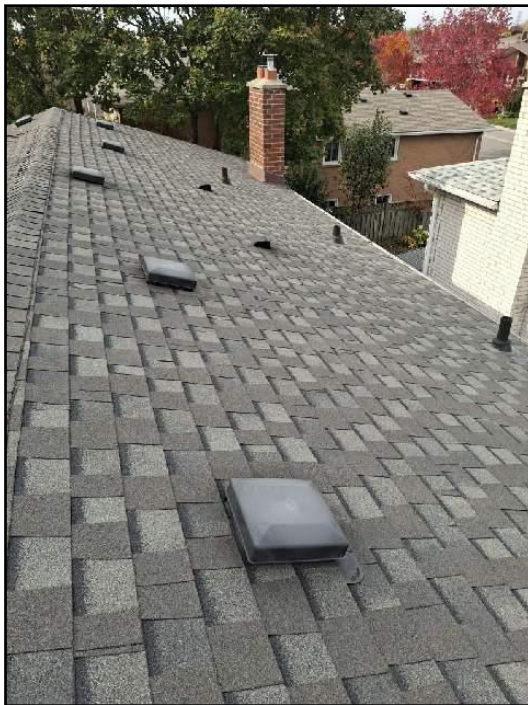
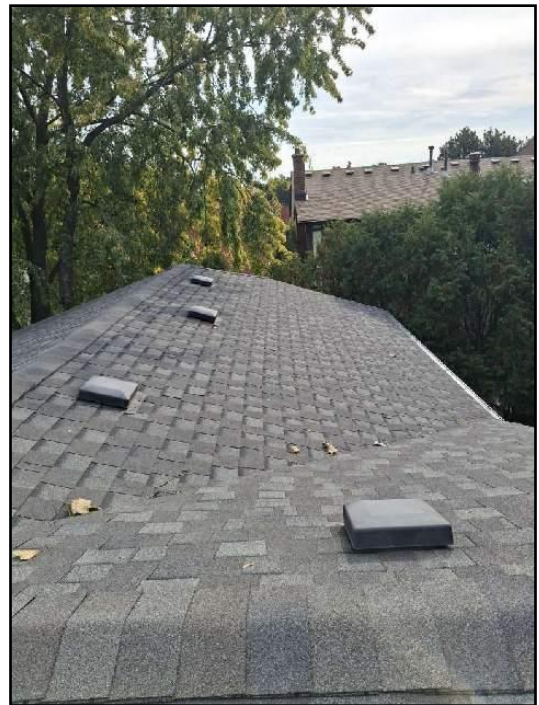
- [Asphalt shingles](#)

Probability of leakage: • Low

Approximate age: • 10 years

2. Condition: • Roof in good condition.

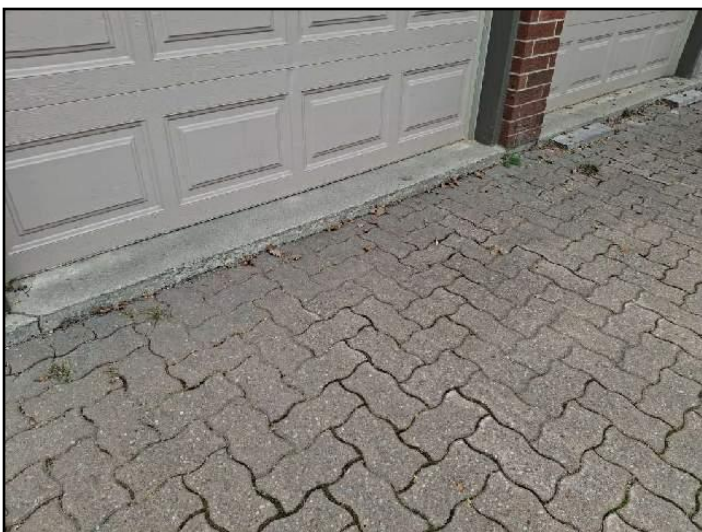
5.

3. Condition: • Relay interlocking to create drainage away from garage and foundation. Eliminate large step up to porch and trip hazard at west exterior.

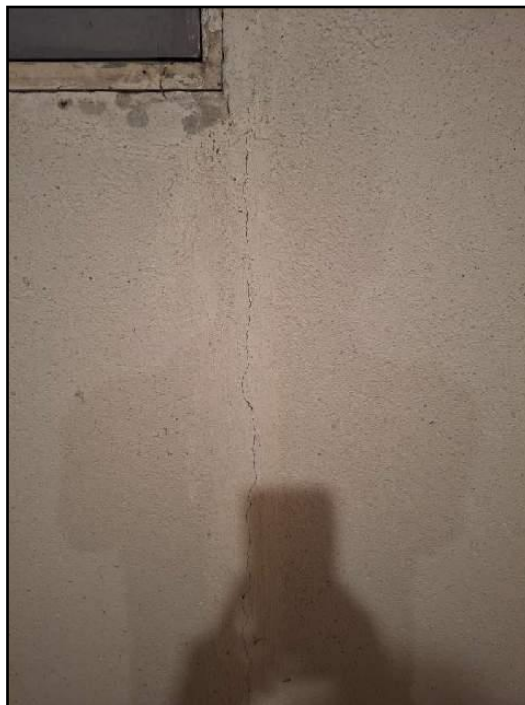
9.

4. Condition: • Typical minor cracks
Typical minor cracks are not structurally significant but indicate areas where foundation is most vulnerable to leakage. See INTERIOR re leakage.
Implication(s): Chance of water entering building
Location: Various Basement
Task: Repair

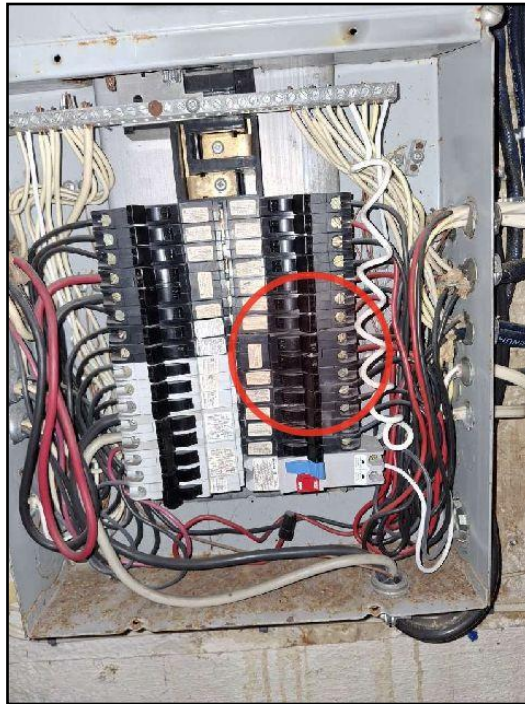
10.

5. Condition: • Oversized breaker (breaker too big).
Replace oversized 40 amp breaker with 30 amp.

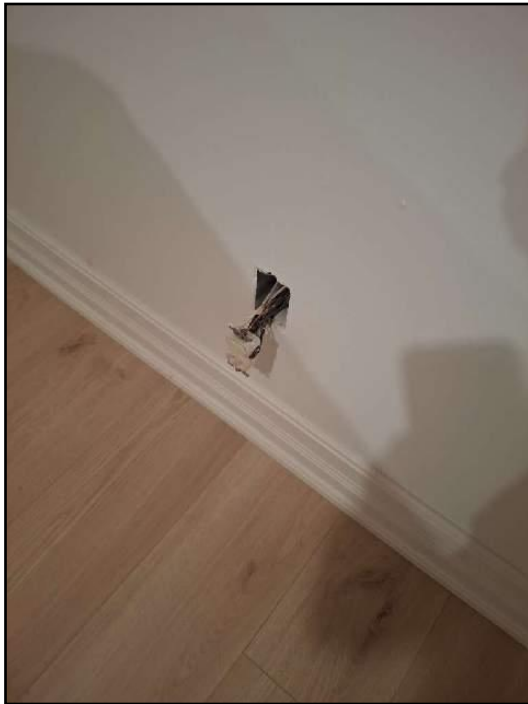
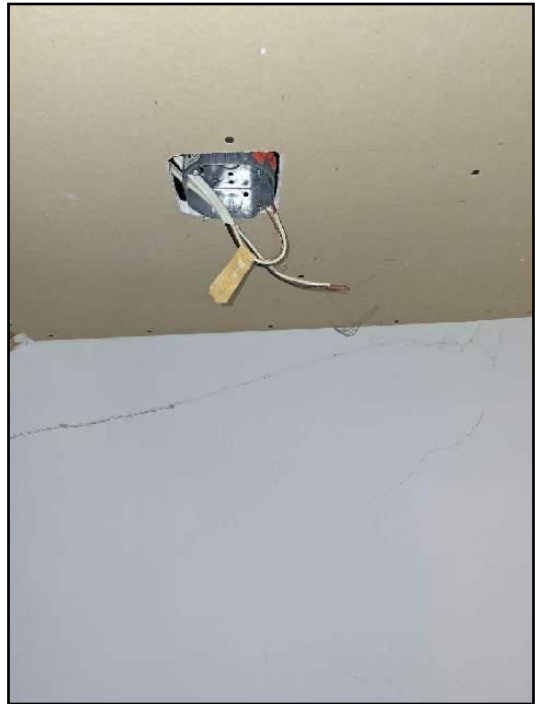
7. Condition: • Some wiring clean up needed.

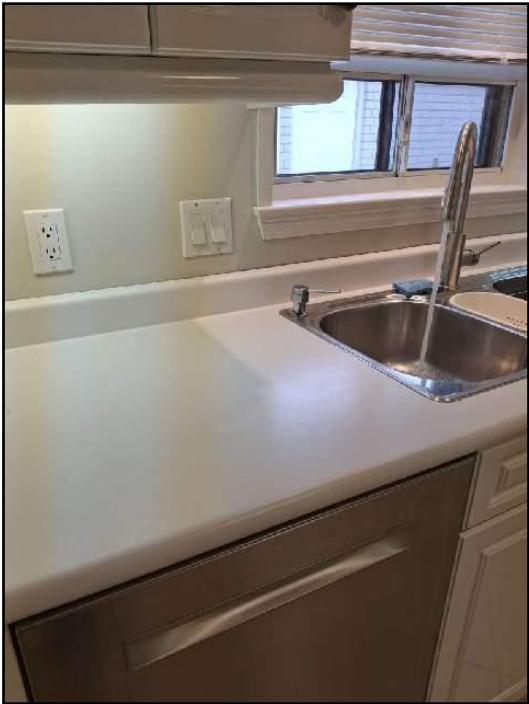
13.

8. Condition: • [GFCI/GFI needed \(Ground Fault Circuit Interrupter\)](#)

Recommend gfcı receptacles at all wet locations.

Implication(s): Electric shock

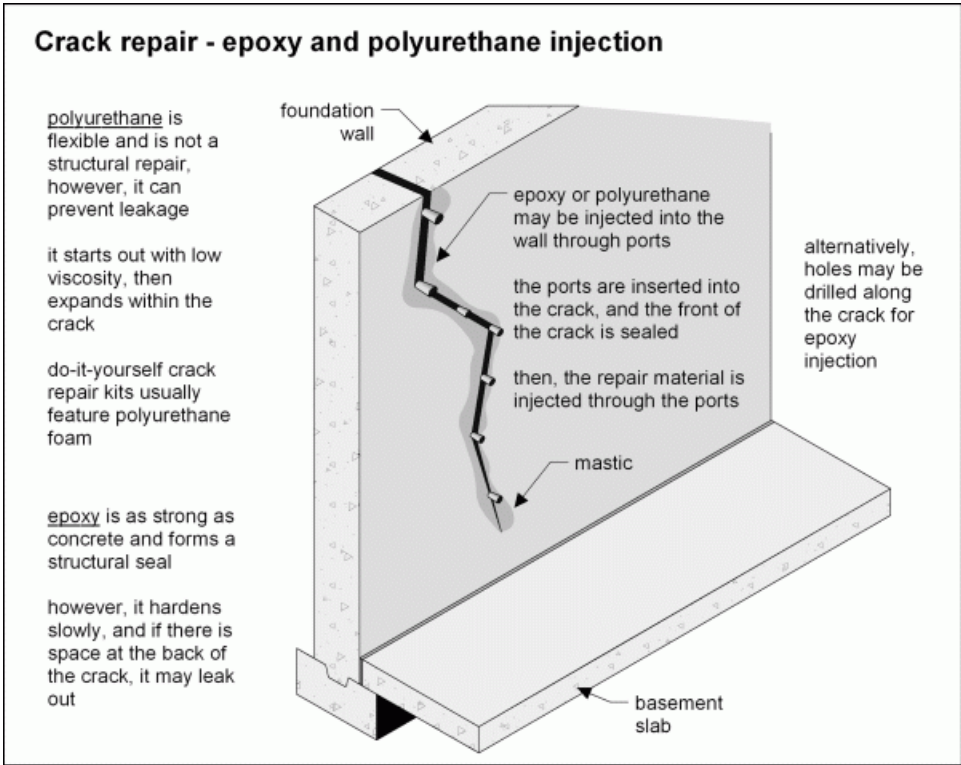
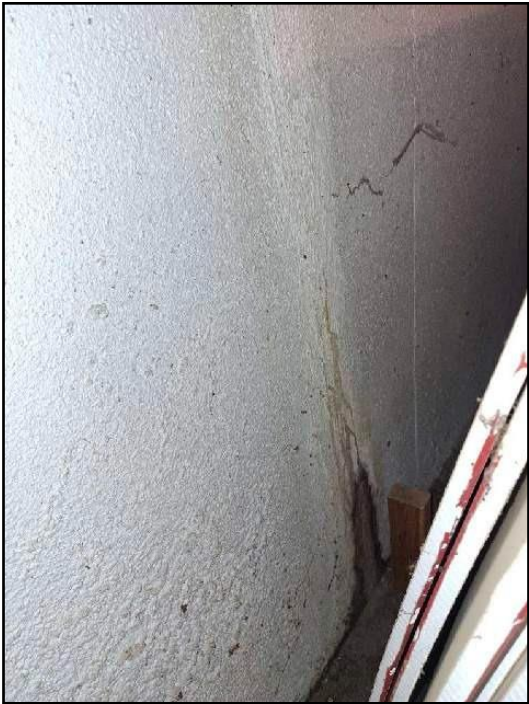
16. Condition: • [Stains](#)

Foundation crack at south basement is leaking. Repair with epoxy injection. Seal any other cracks (one visible) before finishing basement.

Implication(s): Chance of water damage to structure, finishes and contents
