Your Inspection Report

45 Galley Avenue
Toronto, ON M6R 1G9

Wednesday, October 16, 2024

RE: Report No. 4108, v.3
45 Galley Avenue
Toronto, ON
M6R 1G9

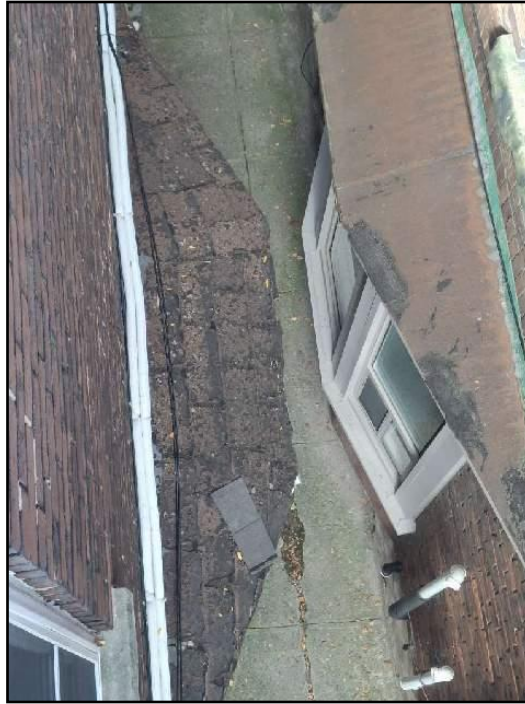
6.

1. **Condition:** • [Old, worn out](#)

Reshingle dining room bay window.

Implication(s): Chance of water damage to structure, finishes and contents

Location: East Bay Window

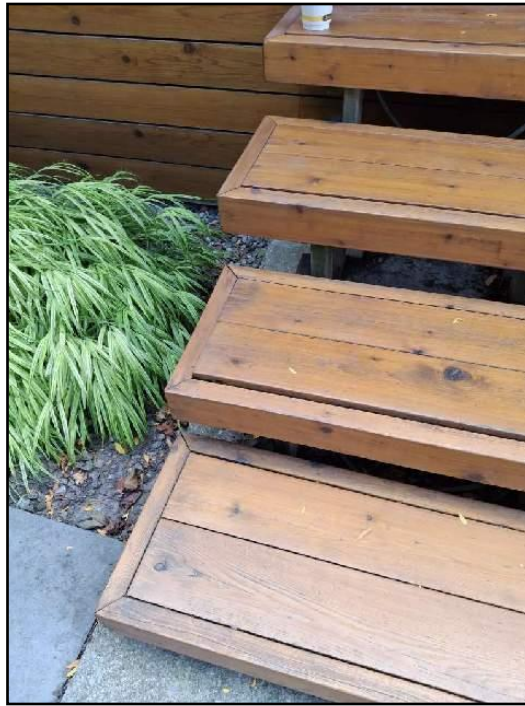
7.

2. Condition: • Trip hazard

Resecure loose front step.

Implication(s): Trip or fall hazard

Location: Front Porch

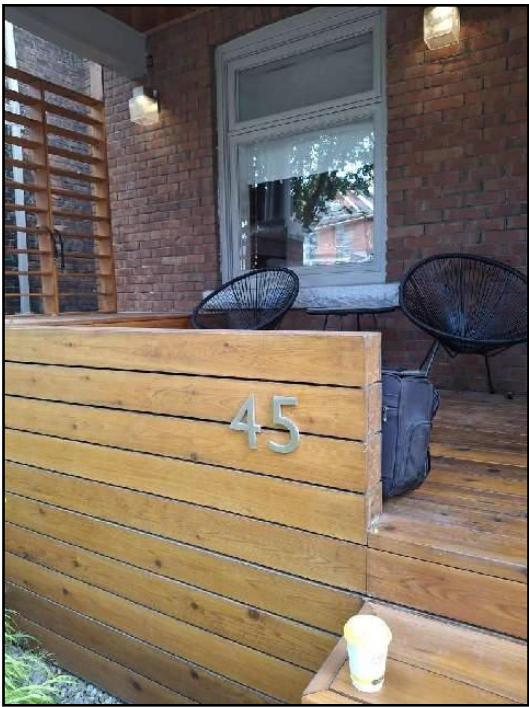
8.

3. Condition: • [Too low](#)

Porch guardrail too low, handrail openings too large. Back entrance stairwell missing handrail.

Implication(s): Fall hazard

Location: Various Exterior

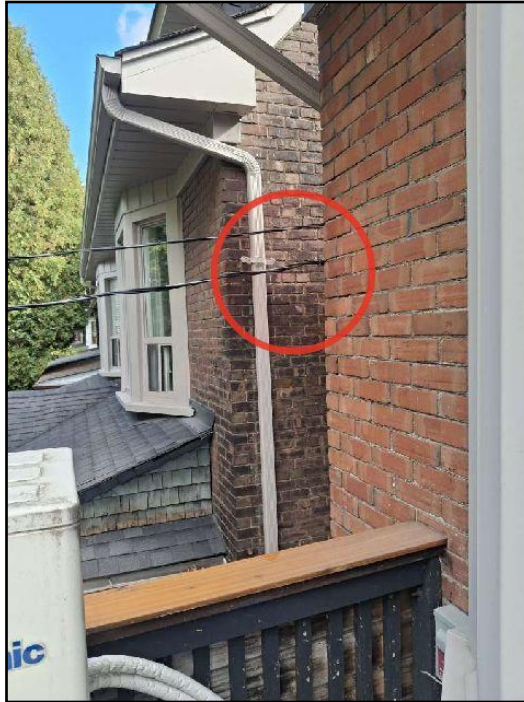
9.

6. Condition: • Prevent contact with wires by occupants of balcony by raising section of railing or shrouding wires.

Location: Northeast Exterior

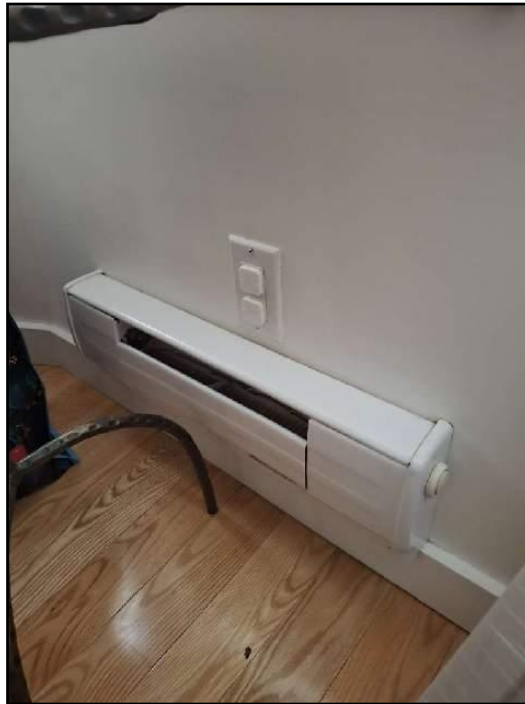
10.

7. Condition: • Poor location

Disable heater or outlet.

Location: First Floor Dining Room

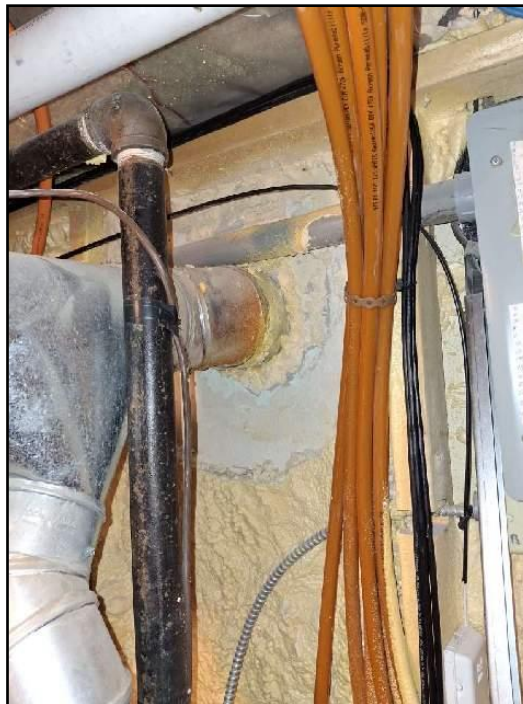
12.

8. Condition: • [Combustible clearance](#)

Single wall flue pipe is in direct contact with plastic electrical conduit and sprayfoam insulation (both combustible). Reconfigure flue connection to create clearance, and remove excess sprayfoam. Flue diameter can likely be decreased since disconnection of water heater. Recommend double wall pipe. Treat exposed spray foam with fire retardant at wall. **DO NOT USE BOILER UNTIL CORRECTED.**

Implication(s): Fire hazard

Location: Basement Utility Room

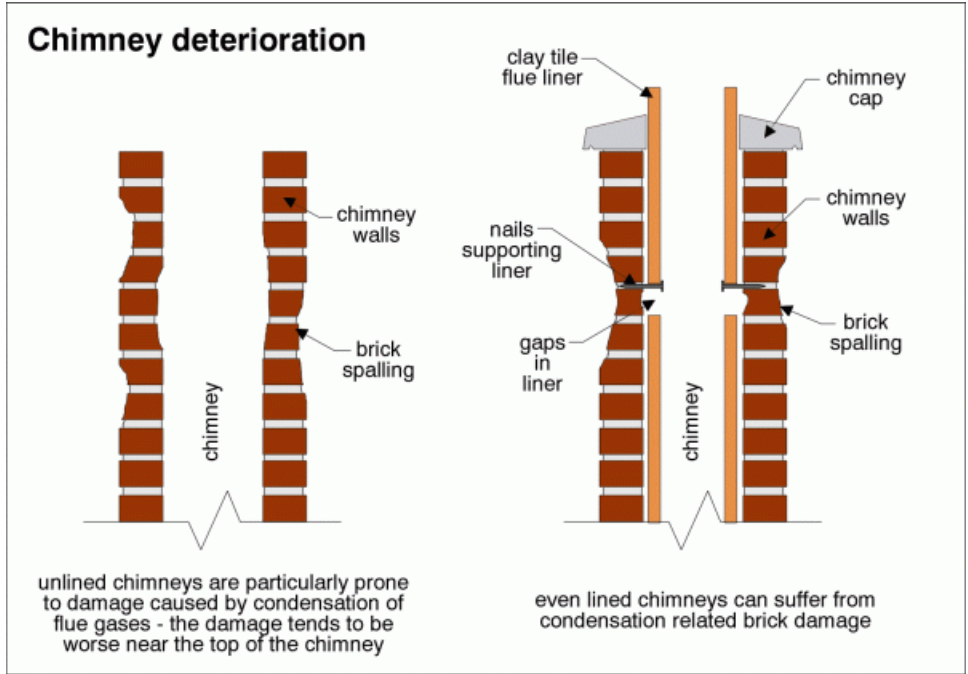
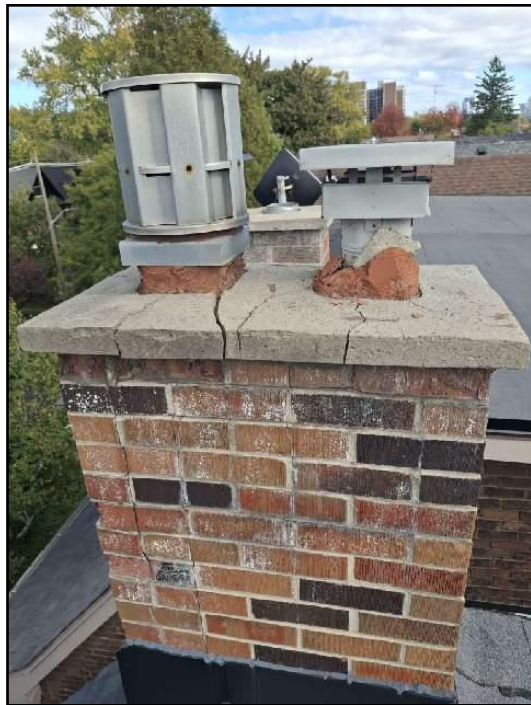
13.

9. Condition: • [Loose, missing or deteriorated masonry](#)

Minor masonry repair needed at chimney.

Implication(s): Material deterioration

Location: Northeast Exterior

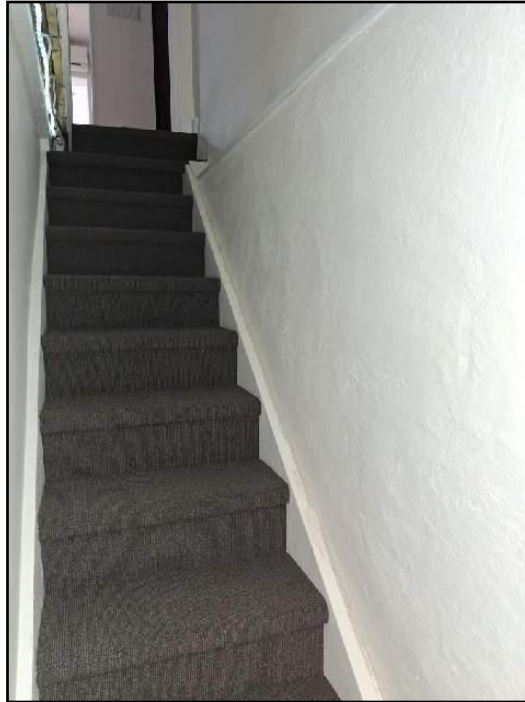
16.

15. Condition: • Missing handrail.

Location: Basement Staircase
