Your Inspection Report

179 Glendale
Toronto, ON

Thursday, May 14, 2015

Report No. 1469, v.3

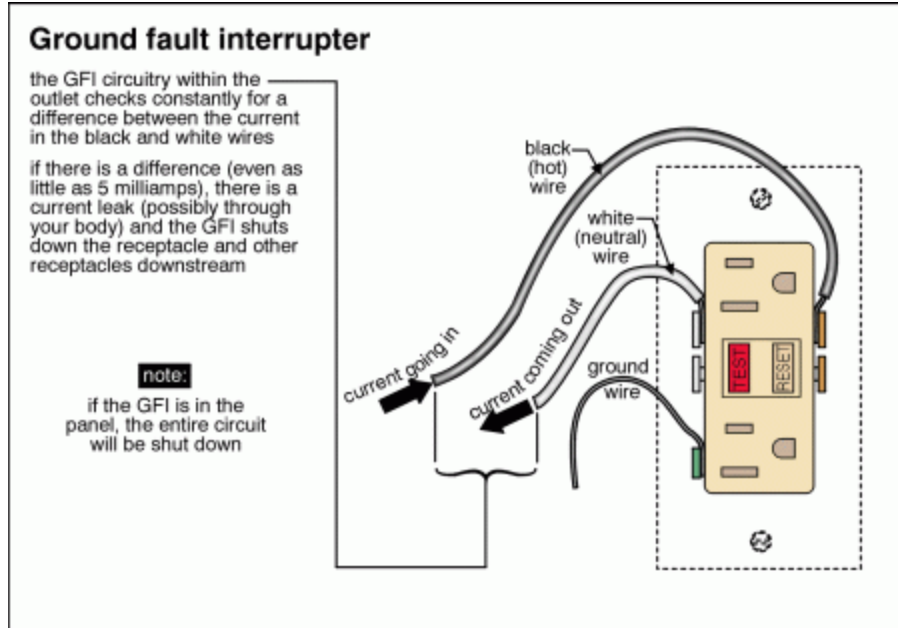
12. Condition: • [No GFI \(Ground Fault Interrupter\)](#)

Implication(s): Electric shock

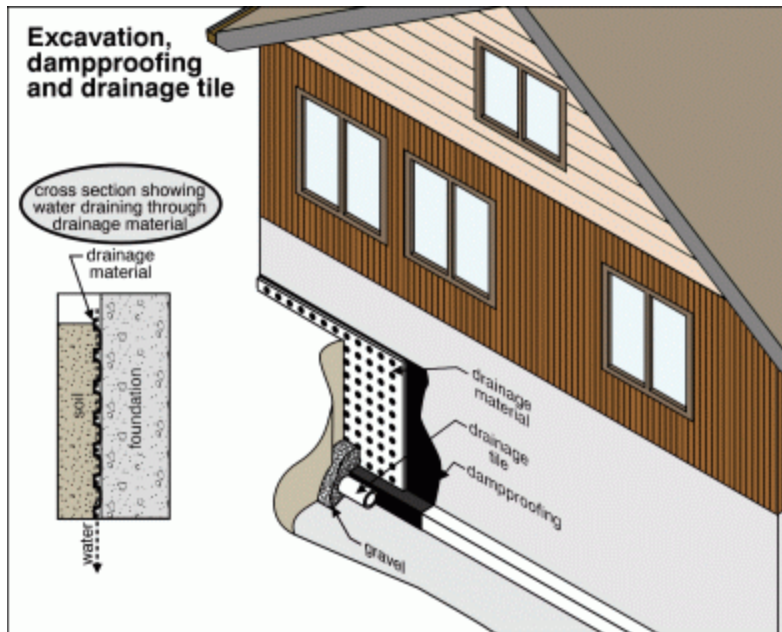
22. Condition: • [Excavation, dampproofing and drainage tile](#)

Implication(s): Chance of water damage to contents, finishes and/or structure

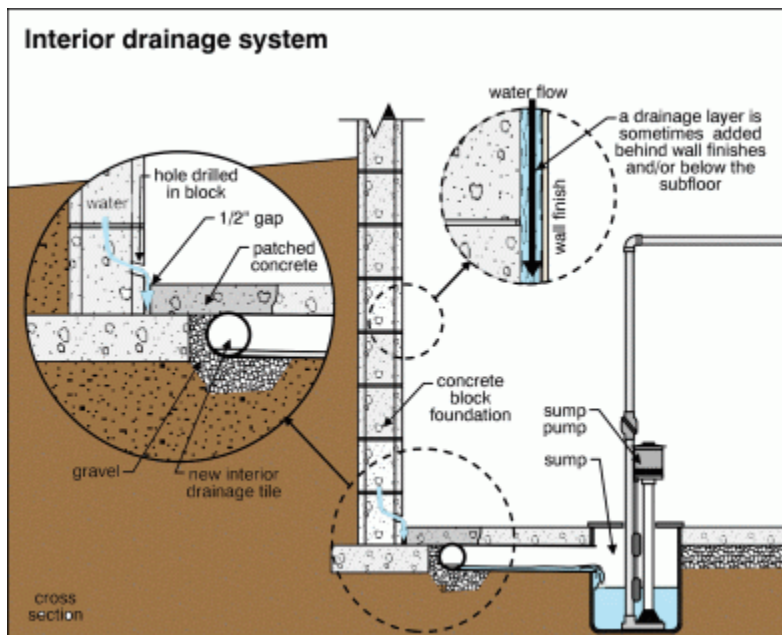
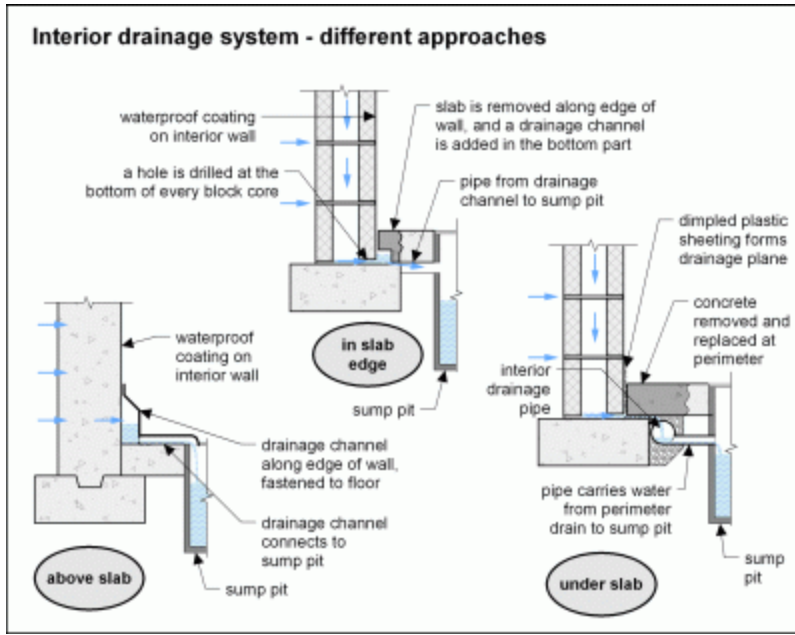
23. Condition: • [Interior drainage system](#)

Implication(s): Chance of water damage to contents, finishes and/or structure
